THE SOURCE HOTEL, LLC, a
California limited liability company,

**DECLARATION OF ROBERT “CHARLIE”
CERVANTES IN SUPPORT OF:**

DECLARATION OF ROBERT “CHARLIE” CERVANTES

5. On March 25, 2021, I conducted a thorough walk-through of the Hotel to personally assess the maintenance issues raised by Shady Bird in the Motion and to take photos of the Hotel, which are included below.

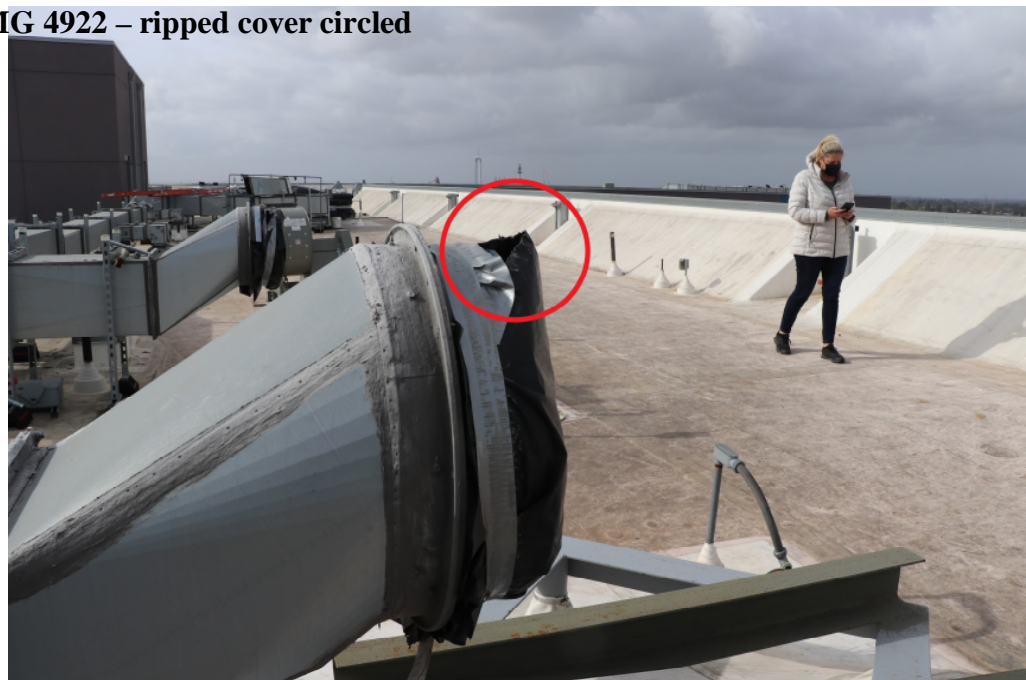
IMG 4922 – ripped cover circled

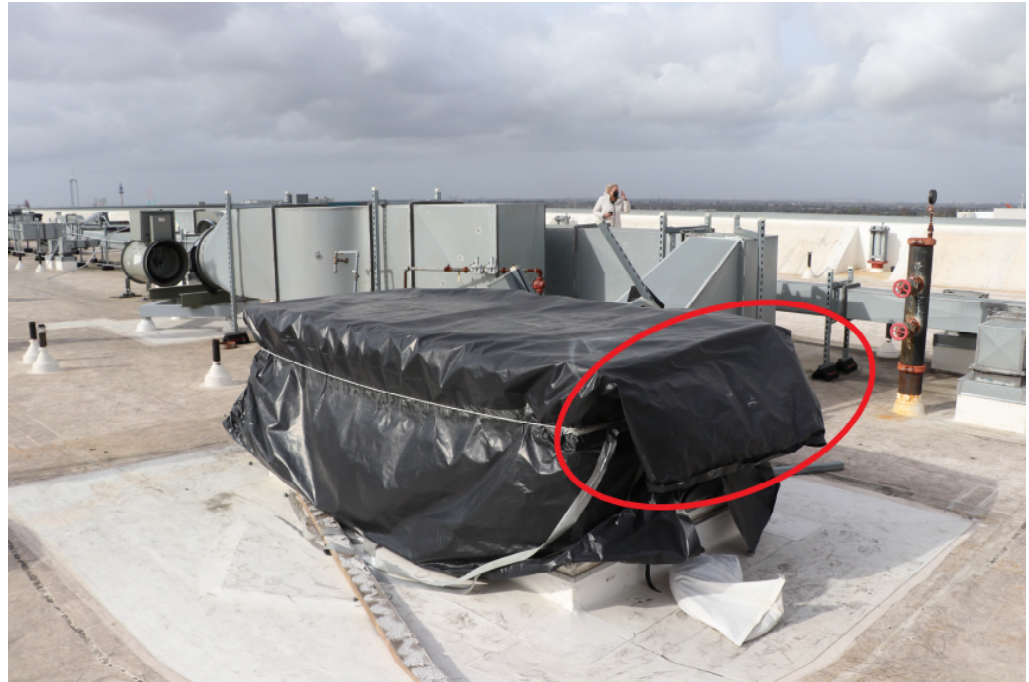
IMG 4926 – loose fasteners

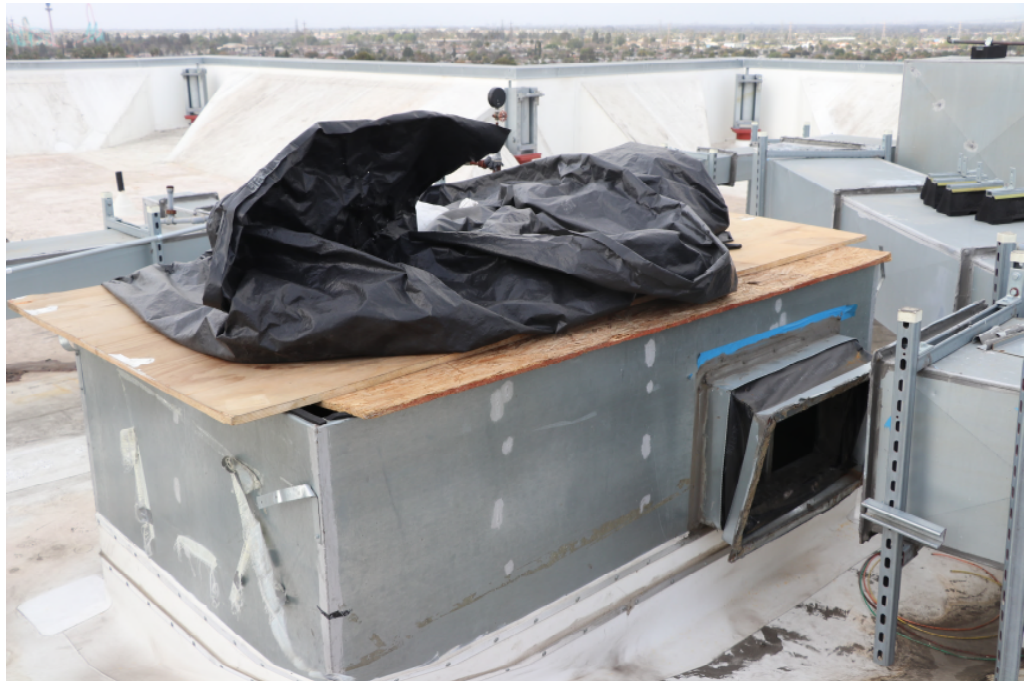
No.	Shady Bird's Allegation	Response/Observations
1	There are substantial roof issues which currently permit the intrusion of water into the structure.	Air vent openings on the Hotel roof were left covered and maintained regularly by M+D until the Receiver took possession. Based on my March 25 walk-through, it appears that the Receiver has not regularly maintained the roof area, as the protective plastic coverings that M+D installed on the vent openings immediately before the Receiver's appointment were still present, but there had been no efforts to fix any tears in the covers or to refasten covers that were blown off. See photos below.

IMG 4954 – blown off cover has been ignored

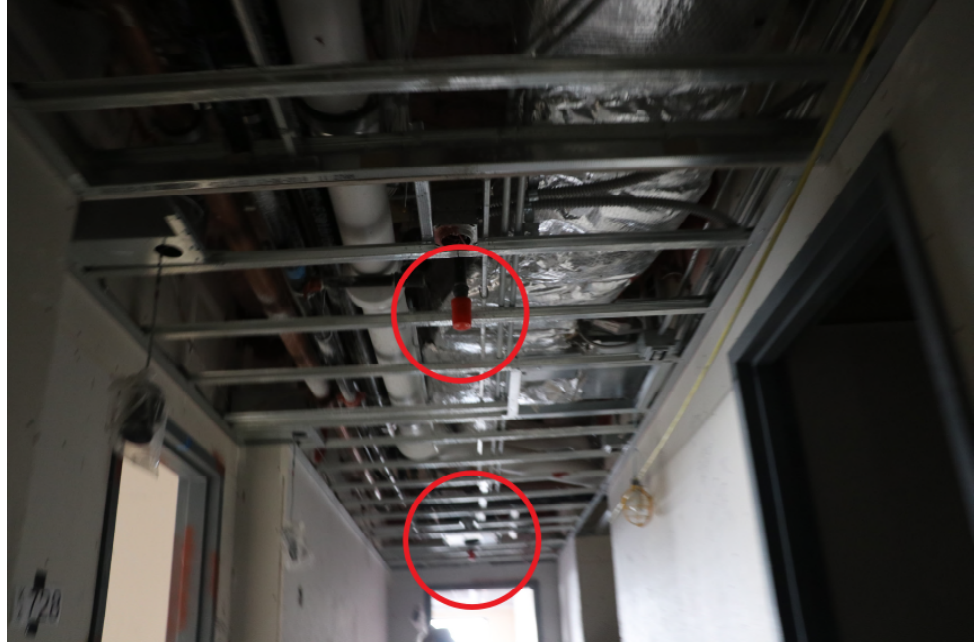
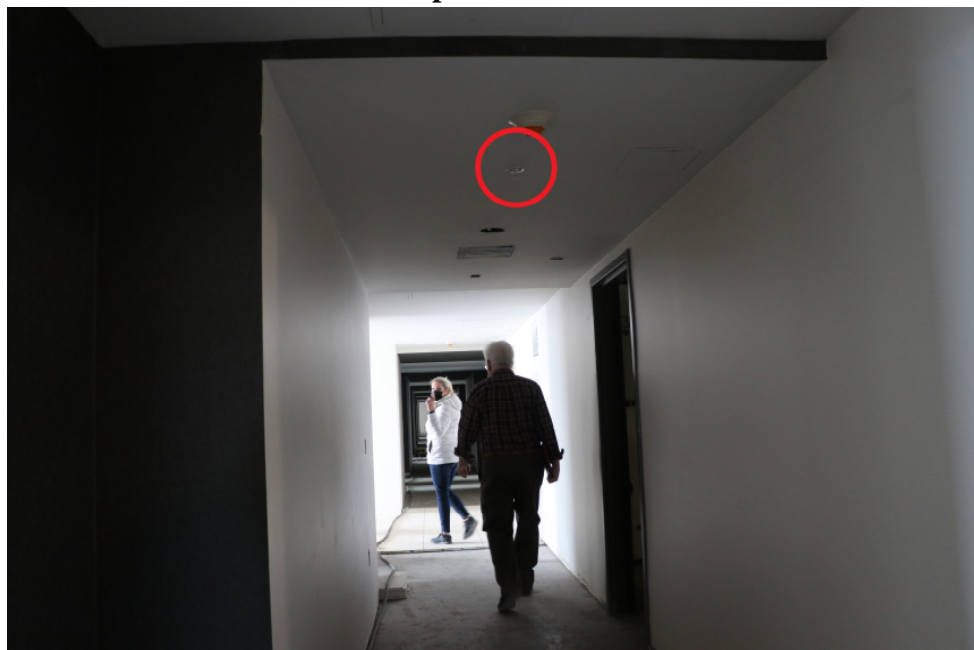
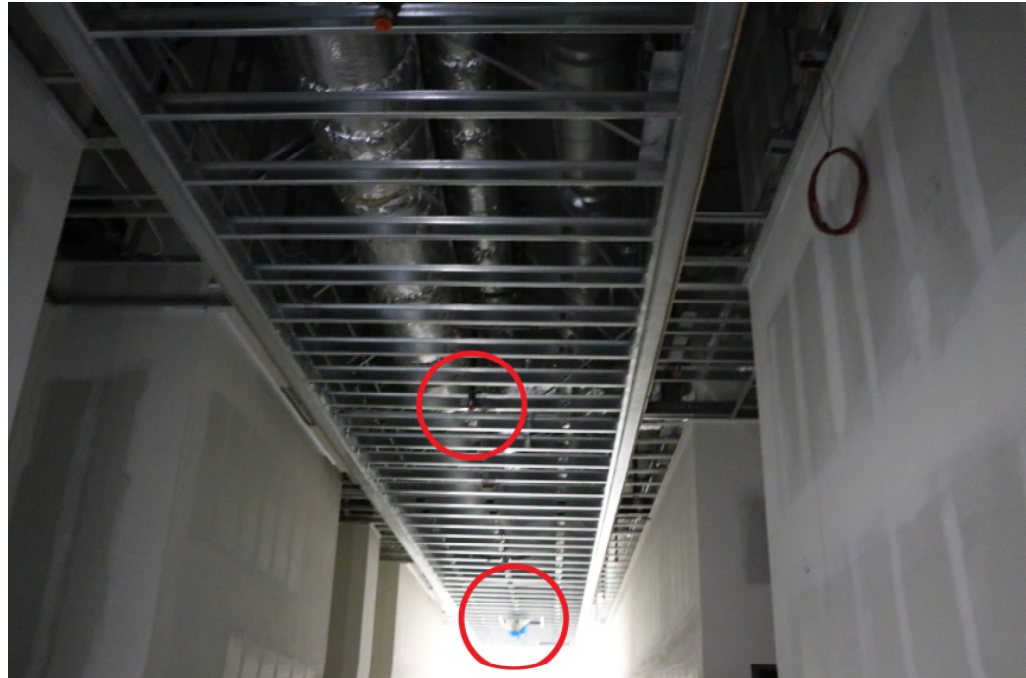
1	3	The fire sprinkler system is not currently capable of providing life-safety protection for the Project.	The water supply lines and the automatic sprinklers have all been installed the Hotel, as confirmed for each of the floors I visited on my March 25 walk-through (floors 1, 2, 4 and 7). However, the protective covers for the sprinklers are still in place because the ceiling drywall and finish have yet to be installed. See photos below.
2			
3			
4			
5

6 **IMG 4978 – Seventh floor hallway**

17 **IMG 5035 – Fourth floor hall is completed**

IMG_5090 – Second Floor Hallway

IMG_5105 – First Floor

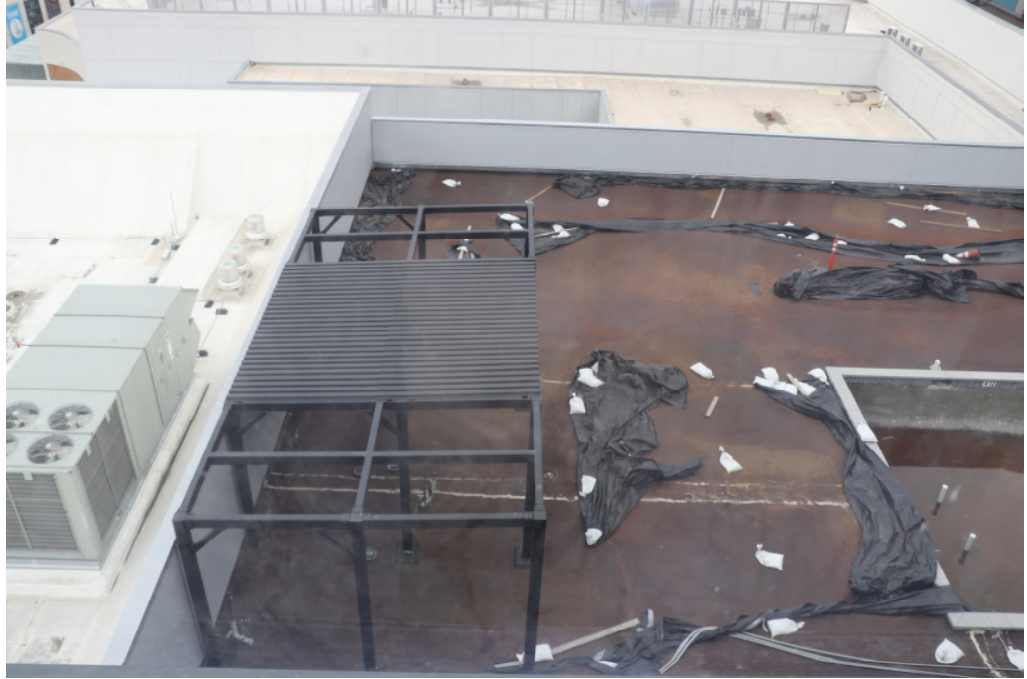
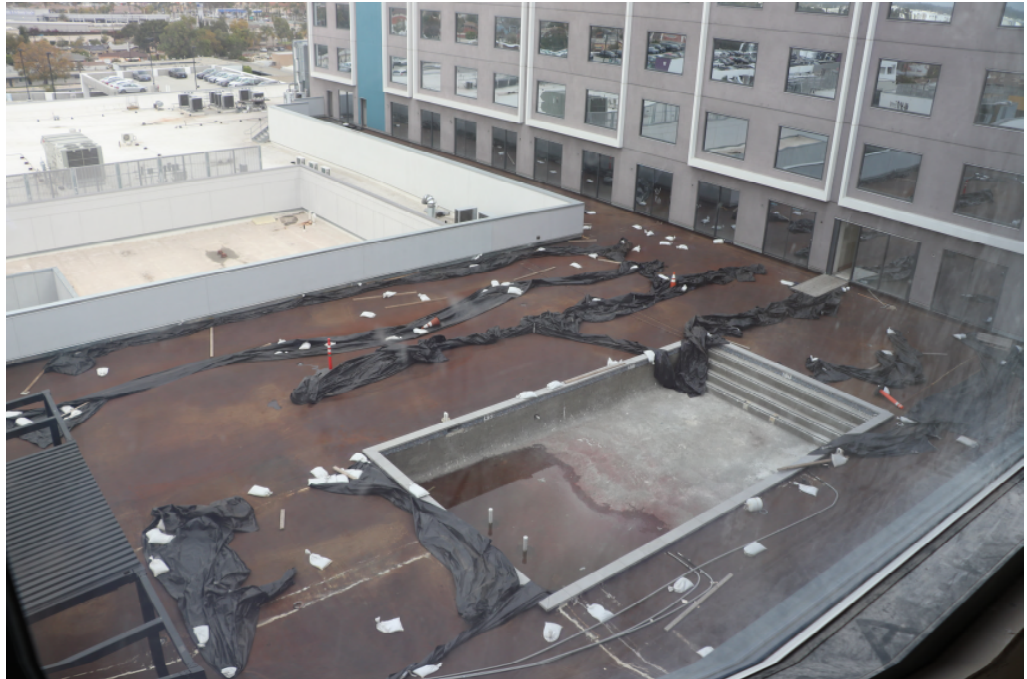
No.	Shady Bird's Allegation	Debtor's Response
4	Due to neglect and exposure to UV rays, the pool deck will need substantial repair.	My construction crew applied sealant over the pool deck and regularly maintained the area, which was covered with a plastic tarp, until the Receiver took possession. Based on the March 25 walk-through, it appears that the Receiver has not regularly checked or maintained the pool deck as

the tarp installed by M+D was torn and had blown off by wind, and there had been no efforts to put the tarp back in place or make other protective arrangements. See photos below.

IMG 4992 – Black tarp blown off, exposing brown surface

IMG 4990 – Black tarp blown off, exposing brown surface

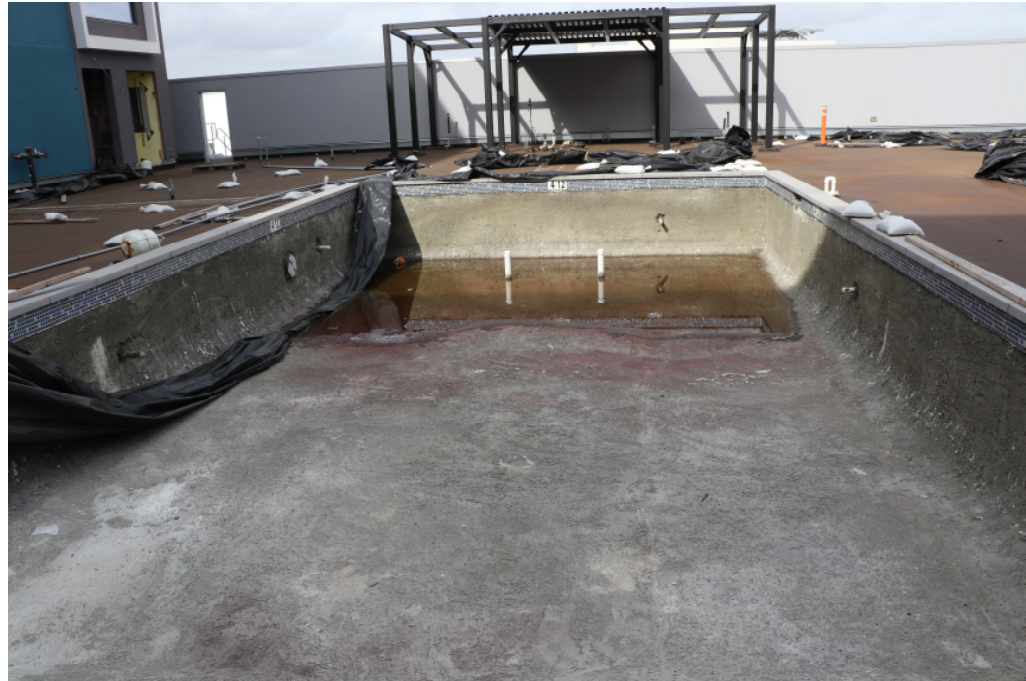
IMG 5047

No.	Shady Bird's Allegation	Debtor's Response
5	The pool has an accumulation of water and trash making it a breeding ground for mosquitos, which may carry the West Nile Virus.	As part of my maintenance duties, my crew and I had been pumping water out of the pool after each rainfall until the Receiver took possession. Accordingly, any water and trash accumulation in the pool occurred after the Receiver took possession. Based on my March 25 walk-through,

it appears that the Receiver has not pumped water out of the pool on any regular basis. See photo below.

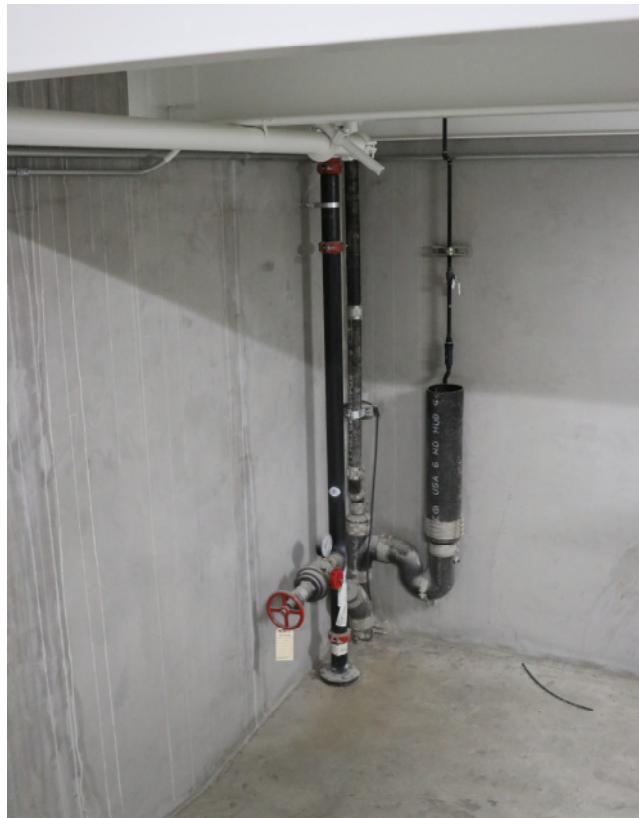
IMG 5097 – sewer line w/ p-trap at First Floor of Retail

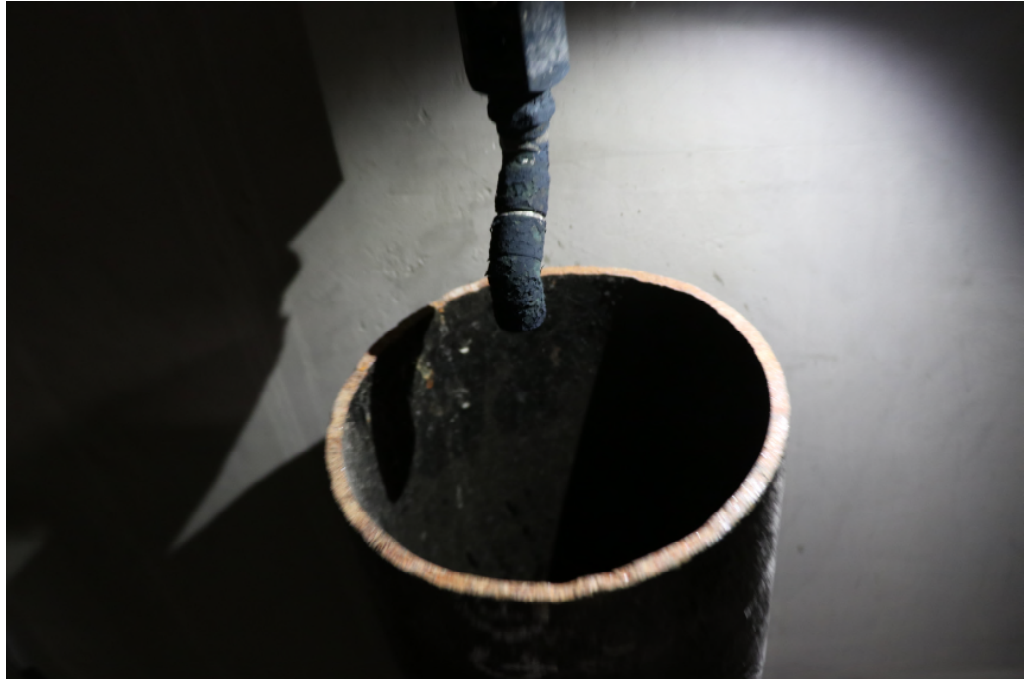
1
2 **IMG 5098 – close up view of sewer opening, with a water sprayer that is not**
3 **spraying any water.**

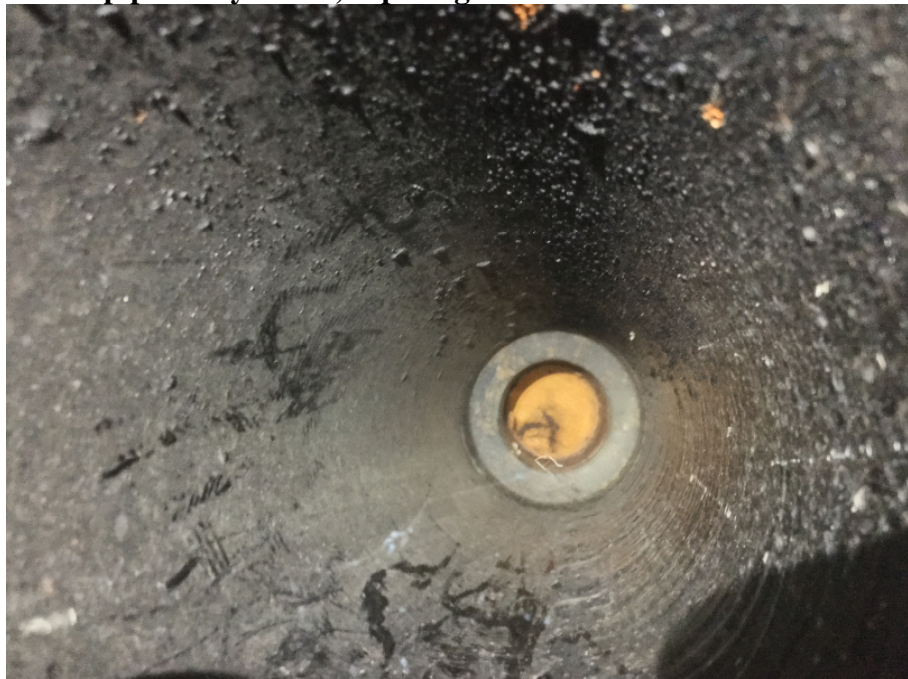
14 **IMG 5098A – pipe is dry inside, exposing odor from sewer.**

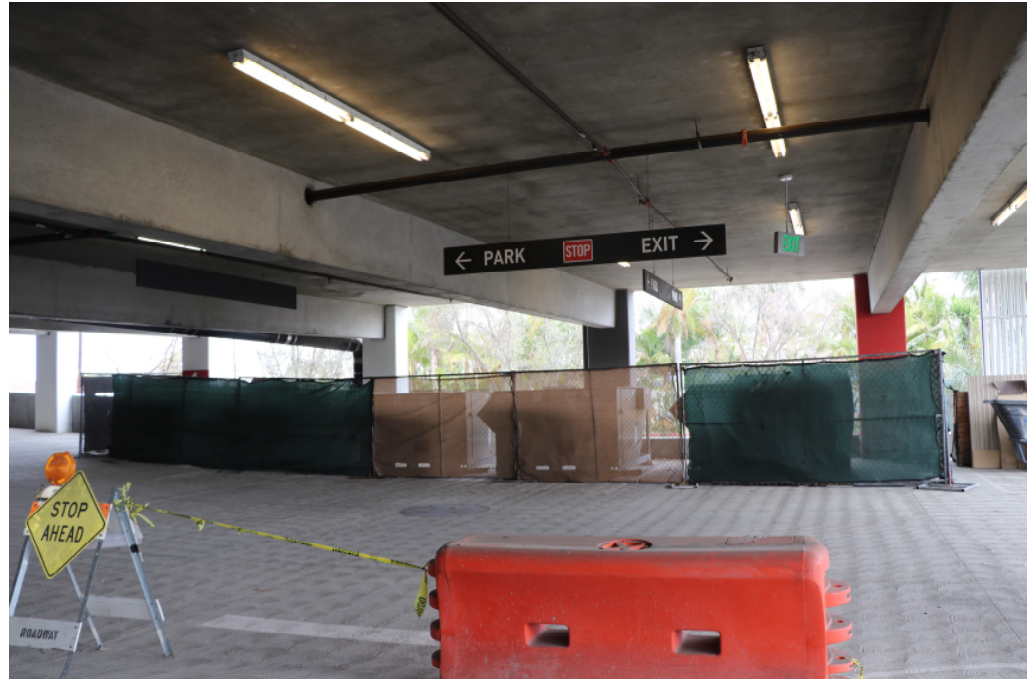
IMG 5113

No.	Shady Bird's Allegation	Debtor's Response
8	HVAC package units have been left unsecured and accessible to thieves and vandals.	HVAC units have been stored in the covered parking structure and have been monitored continuously by the security for the entire "The

Source” complex. Even though the HVAC units are monitored regularly by security, the Debtor and M+D secured the HVAC units with fencing, which remain in place. See photo below.

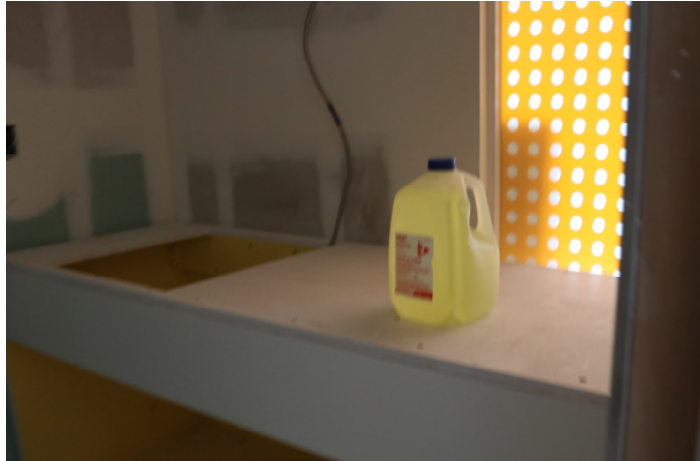
IMG 5017

No.	Shady Bird's Allegation	Debtor's Response
9	There are hazardous and caustic chemical unsecured at the Project.	It is unclear what “hazardous and caustic chemical” Shady Bird is referring as there is no detail provided. Based on my March 25 walk-through, it appears the reference is to a one-gallon yellow chemical that was left <i>sealed</i> on the bathroom counter of Room 725 (see photo below). Nothing else that resembled a chemical was witnessed during my March 25 walk-through.

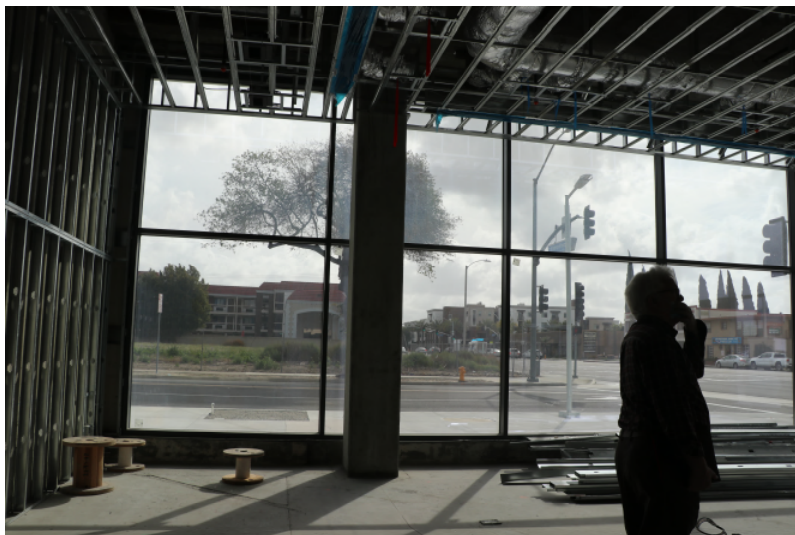
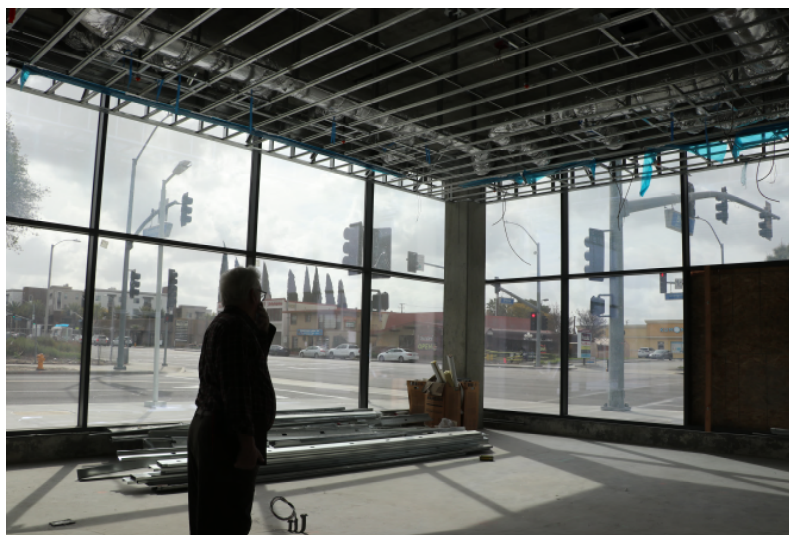
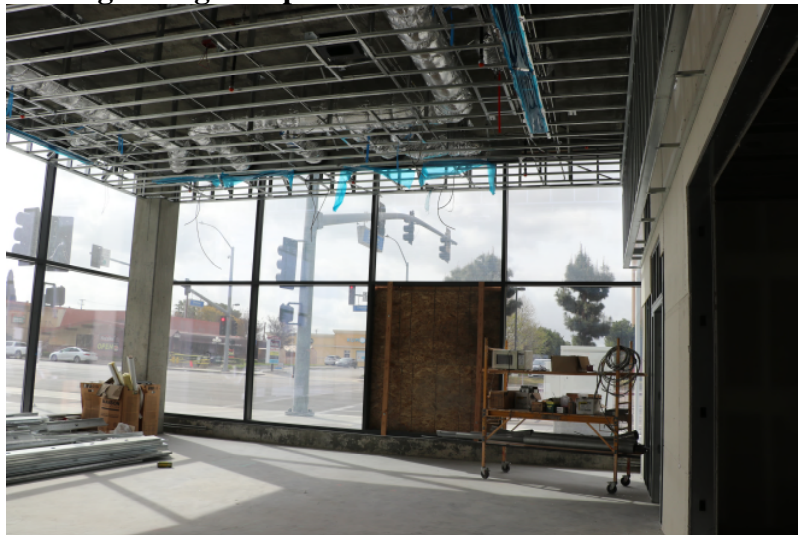
No.	Shady Bird's Allegation	Debtor's Response
10	The Debtor's failure to take reasonable measures to maintain, protect, and secure the project under the operative deed of trust.	This appears to be a "catch all" reference to all of the Items discussed above, but my March 25 walk-through indicated nothing out of the ordinary. The Debtor and M+D took reasonable measures to maintain, protect and secure the Hotel before the Receiver took possession, but it appears that the Receiver has not continued such measures.
11	The Debtor's failure to prevent the project from becoming vandalized, damaged, destroyed, and deteriorated.	While the Debtor was in possession, there was an incident where a vandal broke a layer of glass on a dual-pane storefront glass window facing Orangethorpe Avenue, which my crew cleaned out by removing the broken glass. After the Receiver took possession, there was another incident where a vandal broke through the same window, which resulted in the Receiver installing plywood to cover the opening.

19 **IMG 5103 – facing Orangethorpe.**
